SUBJECT: Emergency Removal of Pine Trees in the Median on Pine Tree Drive

Australian Pine Risk Assessment for Pinetree Drive

January 8, 2014

by
Chuck Lippi
ISA Board Certified Master Arborist #FL0501B
ASCA Registered Consulting Arborist #443
and Danny Lippi
ISA Certified Arborist FL6145A

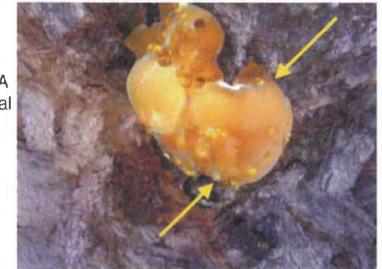
Fungal Conks - During the previous assessment and the latest assessment of the trees, two decay organisms were identified in the field. The first is *Inonotus dryadeus* commonly called "weeping conk" for the amber droplets that form on the surface of fresh conks (Figure 1). It is a root and butt rot fungi and is considered a white rot but shows symptoms of soft rot by preferentially degrading cellulose first making the tree brittle. According to F.W.M.R. Schwarze, et. al., *Inonotus dryadeus* infected trees do not exhibit any symptoms in the crown for a long time "and apparently healthy trees can be suddenly blown down by the wind because their roots are destroyed."⁶ The second fungus found at the site is *Kretzschmaria deusta*, commonly called "brittle cinder" for the burnt appearance (Figure 2) and the characteristic of making infected wood brittle. *Kretzschmaria deusta* is a soft rot that preferentially degrades cellulose before degrading lignin making the butt area brittle much like a ceramic. Samples of old dead

Figure 1 *Inonotus dryadeus* conks are regularly seen on the lower trunks and decaying galls on Pinetree Drive. It is a butt rot or basal rot fungi. Identification is easy because of the amber droplets that form on a fresh conk (arrows).

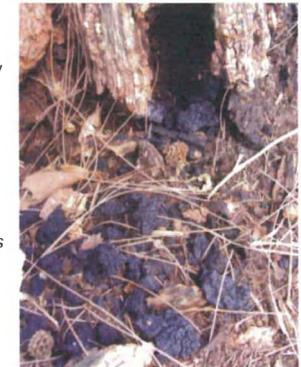
Figure 2 Pieces of black crusty pseudosclerotial plates of what I believe to be the pathogen *Kretzschmaria deusta* litter the ground below a basal cavity. These black crusty plates are found near the base of many of the Australian pines on Pinetree Drive.

stromata (pseudosclerotial plates) of *Kretzschmaria deusta* were sent to the University of Florida Plant Diagnostic Clinic in Homestead, FL. Unfortunately no pathogens could be detected by the lab, only secondary fungi. The lab test did not locate spores of the pathogen which could be used to produce the pathogen in culture. The lab does not do a visual test. Often samples are cross contaminated in the field by other secondary fungi after having been lying at the base of a tree for many months. In spite of the negative laboratory results, I am very certain the decay organism is *Kretzschmaria deusta*. I am guided in my visual diagnosis by the photographs and description provided by Sinclair's authoritative textbook.⁷

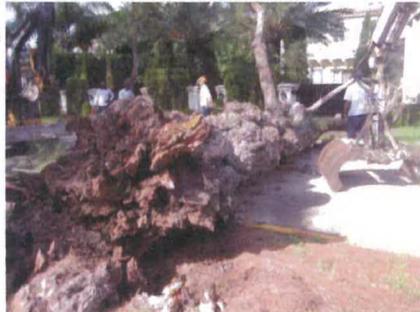
Predominant Failure The type of tree failures that have been reported along Pinetree Drive have been the entire tree falling over caused by root or basal decay. According to verbal accounts, five Australian pine trees fell during the hurricanes of 2004 and 2005. Then a large Australian pine fell on September 15, 2010 across Pinetree Drive at 34th Avenue (Figure 4). The cause of this failure on a calm day also appears to have been basal rot. Some small lateral branch failures have occurred from time to time but these are not documented and appear to be without incident and minor in nature. Apparently there has been another tree failure on Pinetree Drive sometime after the previous 2010-2011 assessment. However, that incident occurred before the City's current Urban Forester Mark Williams was hired so there is no historical information available on the exact cause of the failure.

Figure 4 This tree fell on a calm morning on September 15, 2010. Notice the base of the tree is decayed and has become disconnected from any supporting roots.

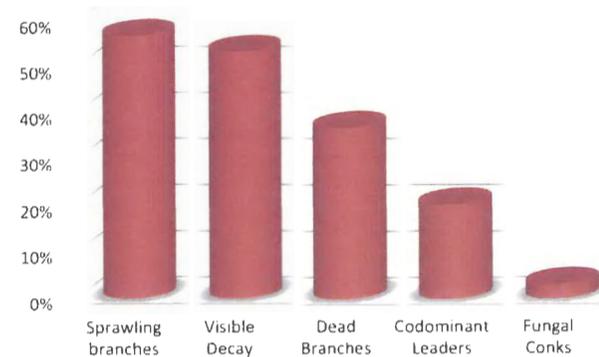
Structural Defects (Figure 6): The two main defects are sprawling branches and visible decay (Figures 7 and 8). The sprawling branches were noted in the previous survey as branches requiring shortening to reduce the lever effect that can make the branches more prone to breakage. A long sprawling branch acts as a long lever. A longer lever acts with greater force on the branch connections when a force such as wind is applied to the lever. The long branches also place more stress on the basal area where the roots are connected to the trunk, which is the predominant failure point of trees with basal decay. The Australian pine trees are old, veteran trees and as such have a considerable amount of decay in the basal area, trunk and branches. The third defect is dead branches. Thirty-seven percent of the trees have dead branches either over the median or the street (Figure 9). Dead branches continue to decay and will eventually fall to the

Figure 6 The most common defects observed are sprawling branches that should be shortened, visible decay, dead branches that must be removed, and codominant leaders. Fungal conks are the fruiting bodies of decay fungi. Not all decay will produce fruiting bodies at the same time.

ground or street if not attended to through regular maintenance. **Codominant** leaders are a structural defect that makes a branch fork more prone to failure. Shortening the leaders above the codominant fork is the proper mitigation for codominant leaders on aging trees. Finally fungal conks are fruiting bodies. Only a small portion of trees with decay will exhibit fruiting bodies of wood-decay fungi at one time.

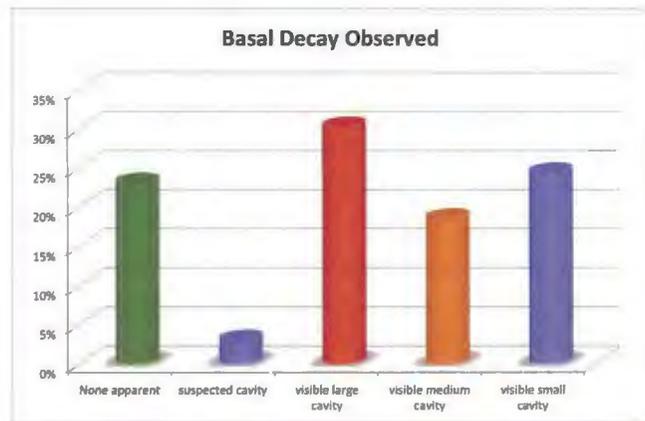
Decay: Decay is considered in this report a structural defect not a health defect. Two types of decay were classified — basal decay (Figure 7) which causes the roots to decay where they meet the trunk and decay in the trunk and branches (Figure 8). Basal decay can cause catastrophic failure of the entire tree falling over. Trunk and branch decay can cause portions of the trunk or branches to fail. Reducing weight by pruning above the decayed area, if the decayed area is not too large, is one way to mitigate the decay defect without removing the tree.

Figure 7 Combined, the large and medium size basal cavities (red and orange) were apparent visually on 49 percent of the trees.

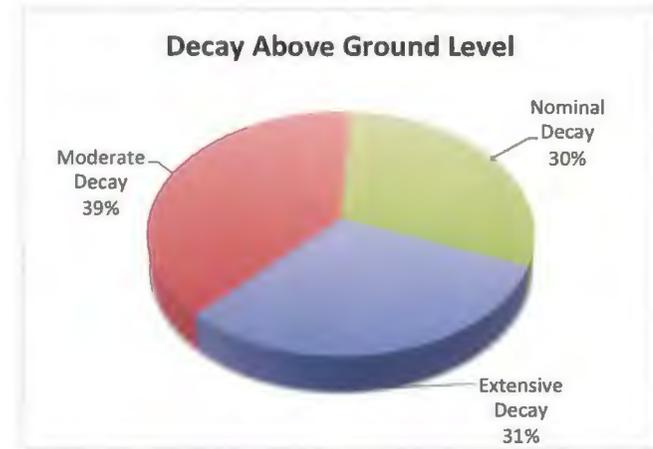
Figure 8 Seventy percent of the trees had either moderate or extensive decay on the trunk and or branches.

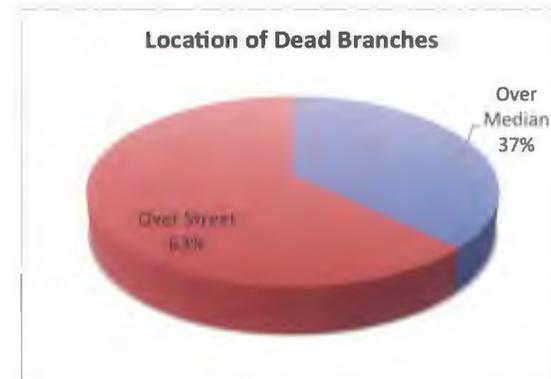
Figure 9 Of the 107 trees that had dead branches, 63 percent were over the street and had a higher potential for causing damage or injury if they were to fail. The dead branches over the median posed a lower threat.

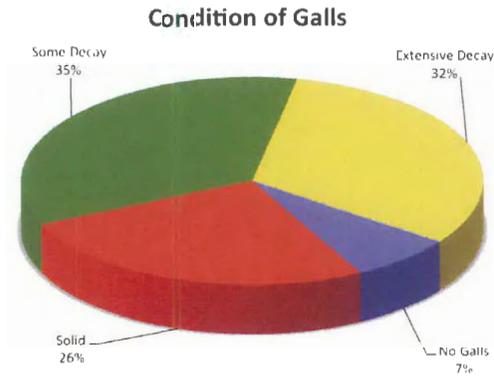
Figure 10 We have observed that galls with more extensive decay tend to pass that decay into the trunk

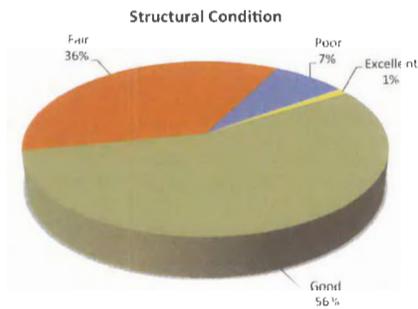
Figure 11 When the overall tree structure was evaluated, 56 percent of the trees are considered good with 36 percent considered fair.

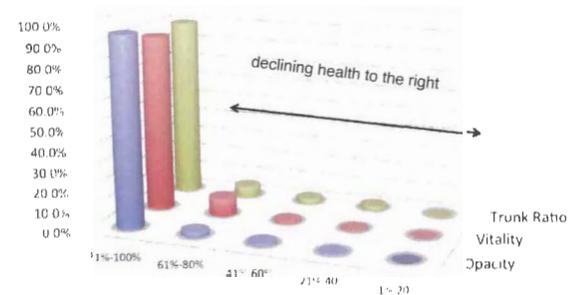
Tree Health
Measured by Opacity, Vitality and Trunk Ratio

Figure 12 Tree health was very good considering opacity, vitality and trunk ratio. The entire population is generally very healthy.

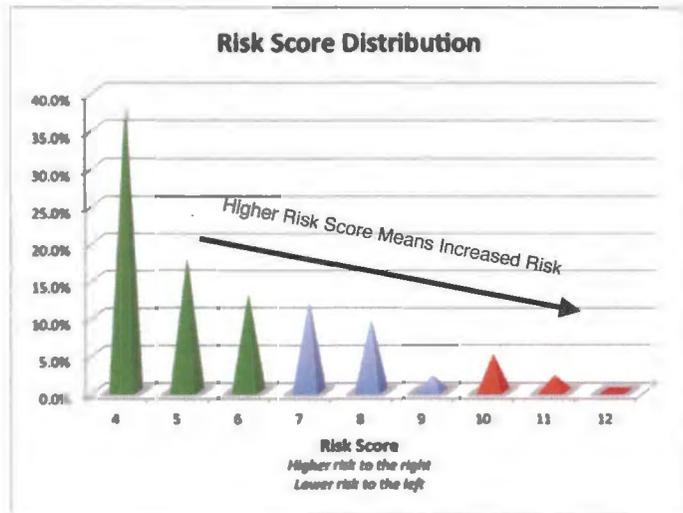
Figure 13 Twenty-one trees have a Risk Score of 10 to 12. Sixty-nine have scores between 7 and 9 and 199 trees have low Risk Scores from 4 to 6.

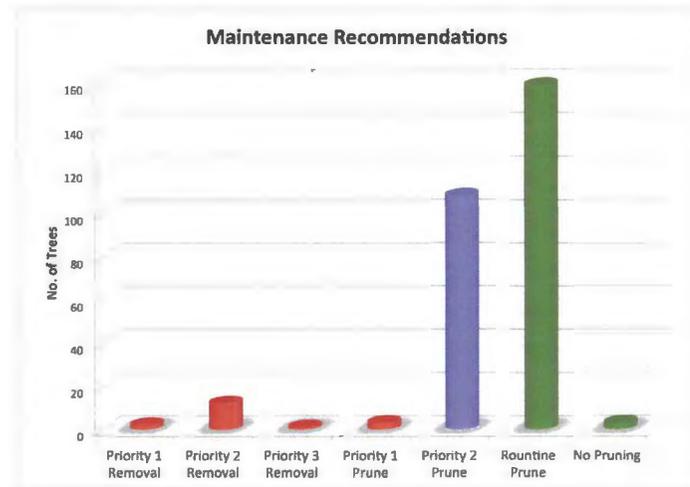
Figure 14 Fifteen trees were selected for removal. Three trees were marked for Priority 1 prune which means there was a hanger or urgent problem to correct. One hundred eight trees were marked for corrective pruning as soon as the removals and Priority 1 pruning had been done.
