SUBJECT: Park View Island Water Quality Community Workshop

**Assessment of Water Quality
at the Miami Beach Park View Canal
to Identify Sources of the Fecal Indicator Bacteria,
Enterococci**

DRAFT REPORT

University of Miami, Coral Gables, FL
Department of Chemical, Environmental, and Materials Engineering

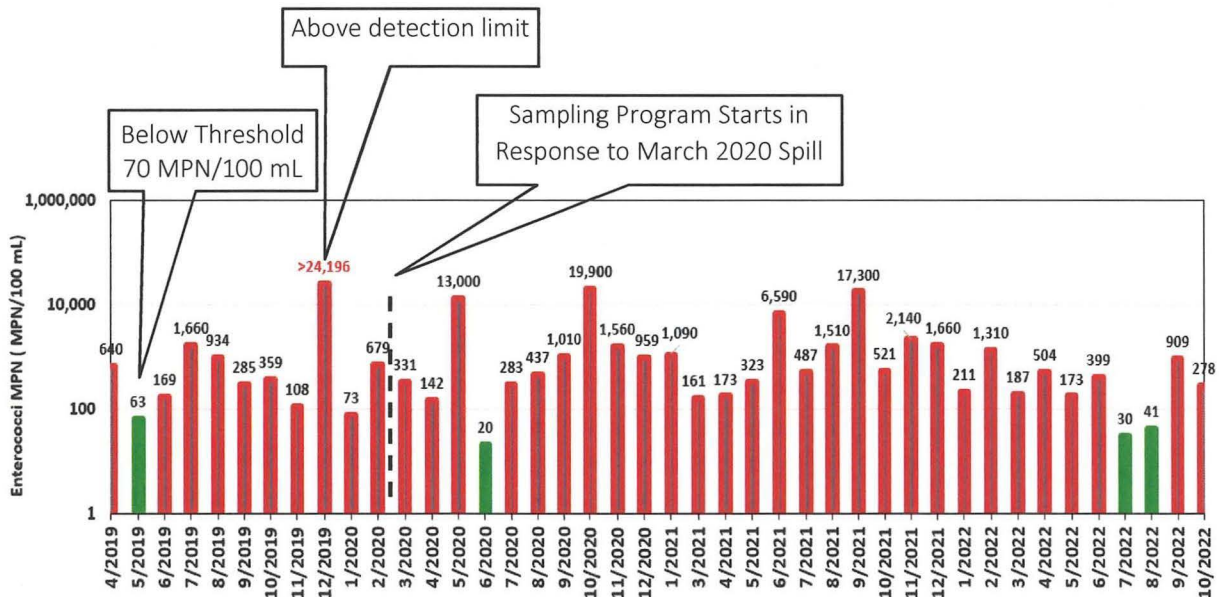
Figure II.1: Results from Monthly Enterococci Measurements at PVC from 4/2019 to 10/2022. Green bars correspond to data points within the 70 MPN/100 mL recommended recreational level whereas red bars correspond to data points which exceed this level. Note the data are plotted on a logarithmic scale due to the wide range of measurements.

Since the monitoring program started in 2019, the fraction of the time the PVC waterway has exceeded the 70 MPN/100 mL threshold has been at or above 80%, with the highest number of exceedances observed for year 2021 when all samples collected exceeded the regulatory threshold 70 MPN/100 mL. For the entire period of record evaluated (April 2019 to October 2022) the PVC exceeded the 70 MPN/100 mL threshold 90% of the time.

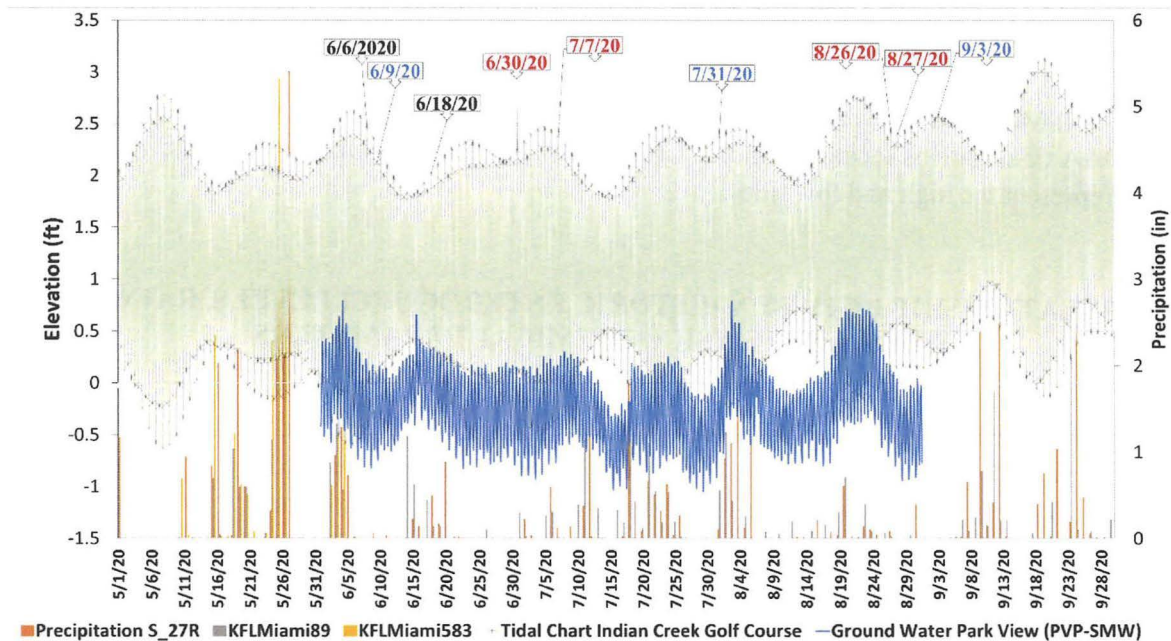
Figure II.3: Time series plot of rainfall, tides and groundwater superimposed on dates and peak enterococci levels measured in catch basins.

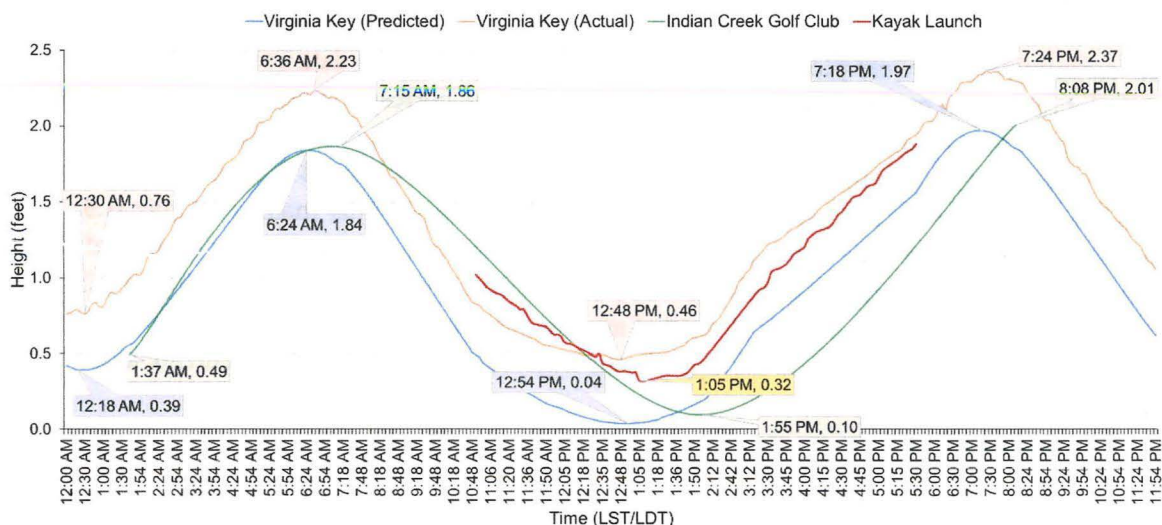
Figure II.4: Measured tidal data at the Park View Canal on July 24, 2022, and tide predictions at the NOAA tidal stations located at Indian Creek Golf Club and Virginia Key stations. The data labels represent the high and low tides.

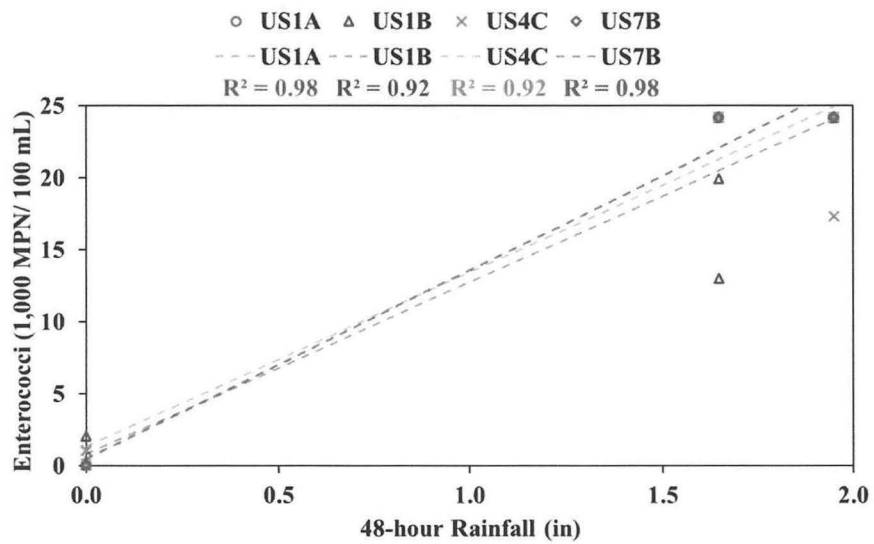
Figure II.8: Linear correlation between enterococci in the upstream samples (US1A, US1B, US4C, and US7B) and 48-hour cumulative precipitation prior to the sampling time based on the Pearson's analysis (R^2).

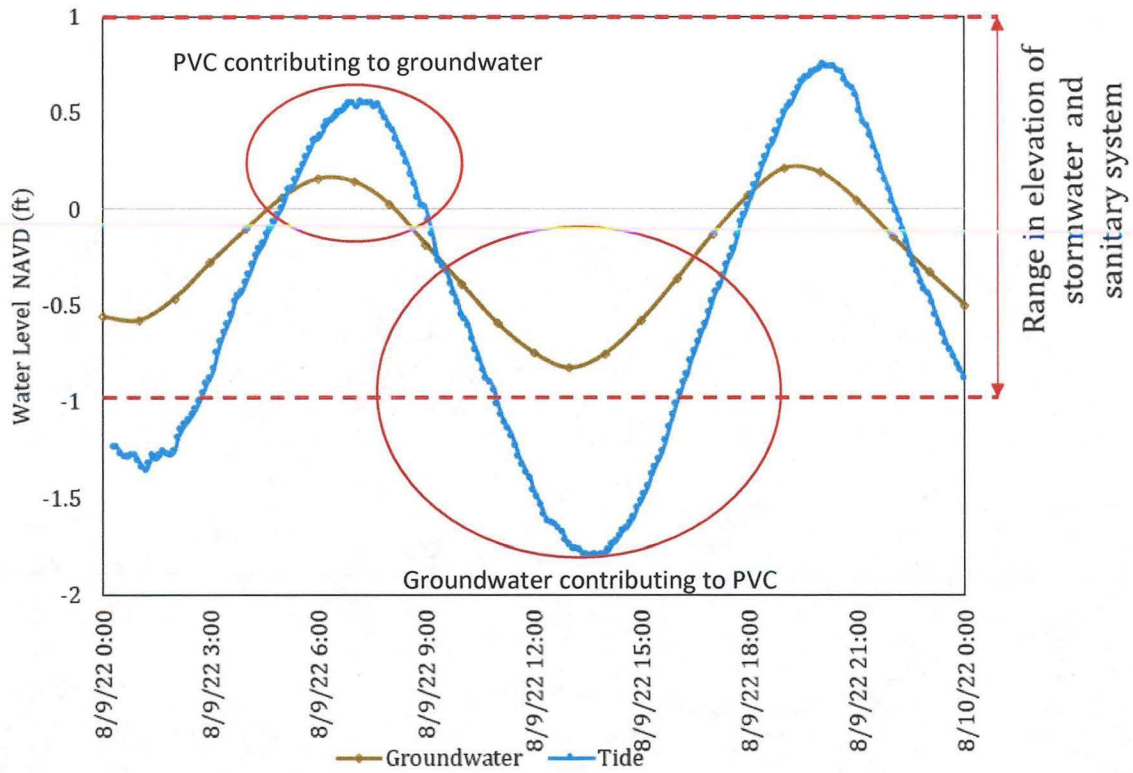
Figure III.5: Estimated tidally driven water levels at PVC and measured groundwater elevation at Parkview Island Park monitoring well.

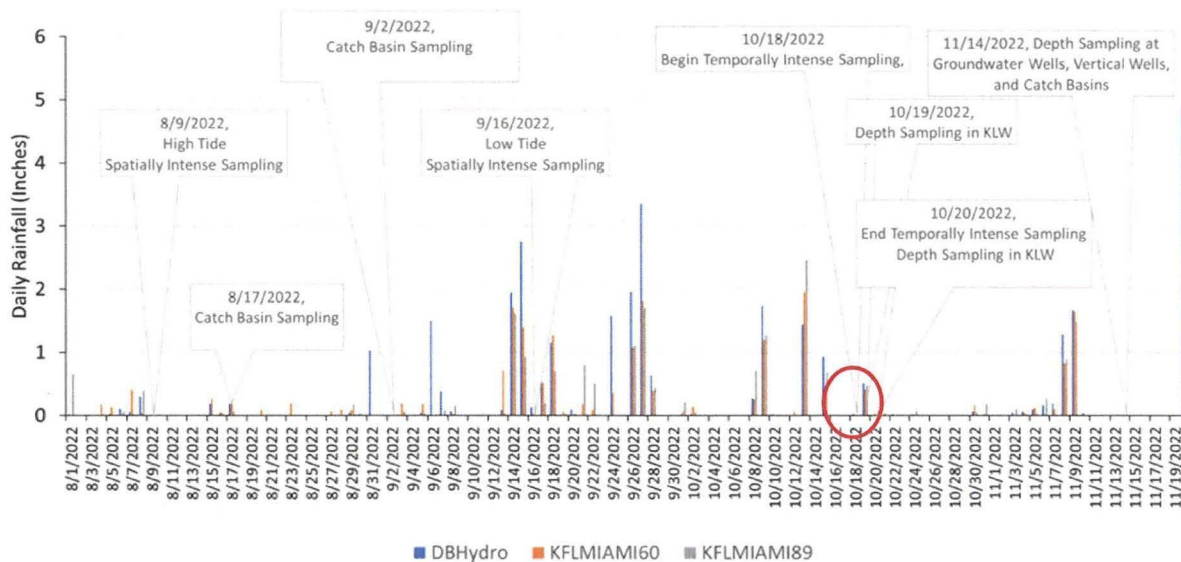
Figure V.1a: Sample collection timeline superimposed on daily rainfall record. Of note, low tide spatial sampling occurred during an antecedent wet period. Period corresponding to the hourly sampling period (over 48 hours) is highlighted by a red circle.

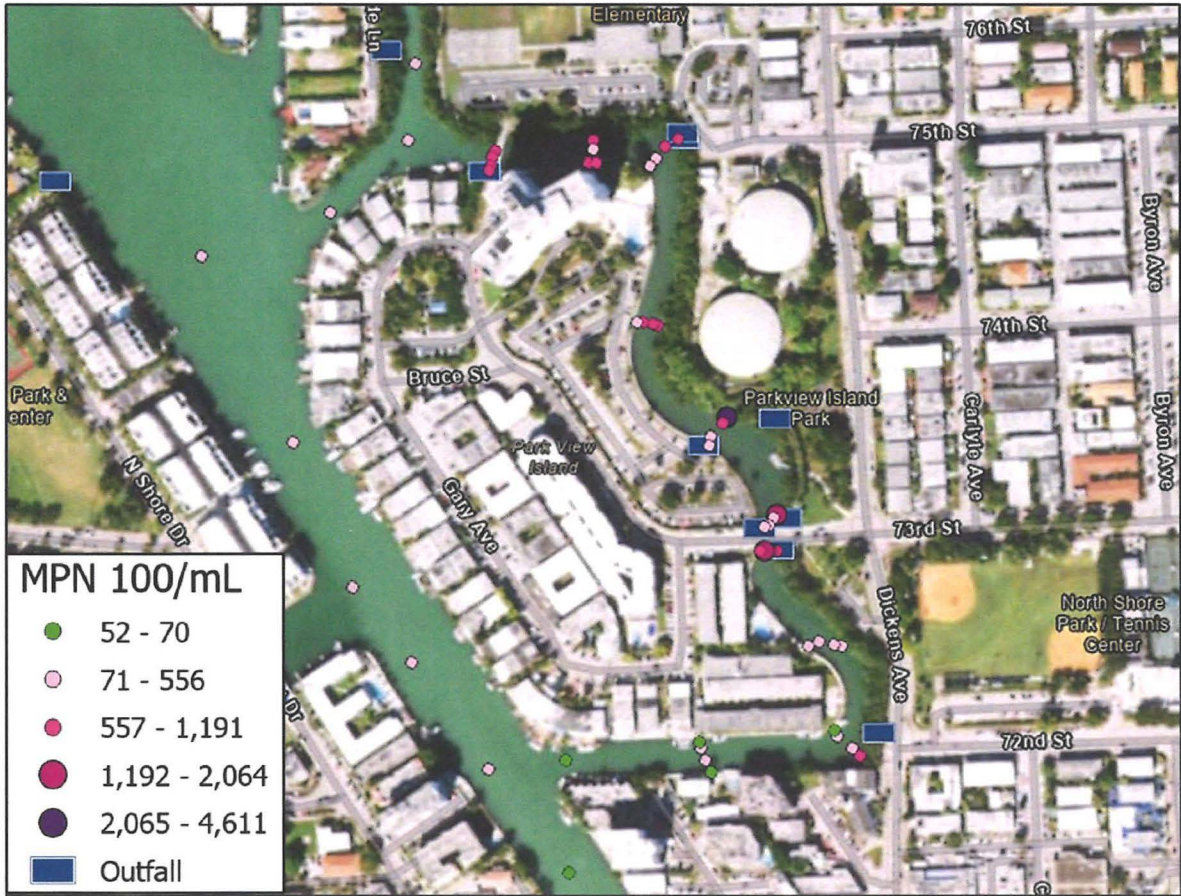
Figure V.2: Map showing measured concentrations of enterococci at the PVC during **high tide** (August 9, 2022). Hotspots shown by large pink and purple circles.

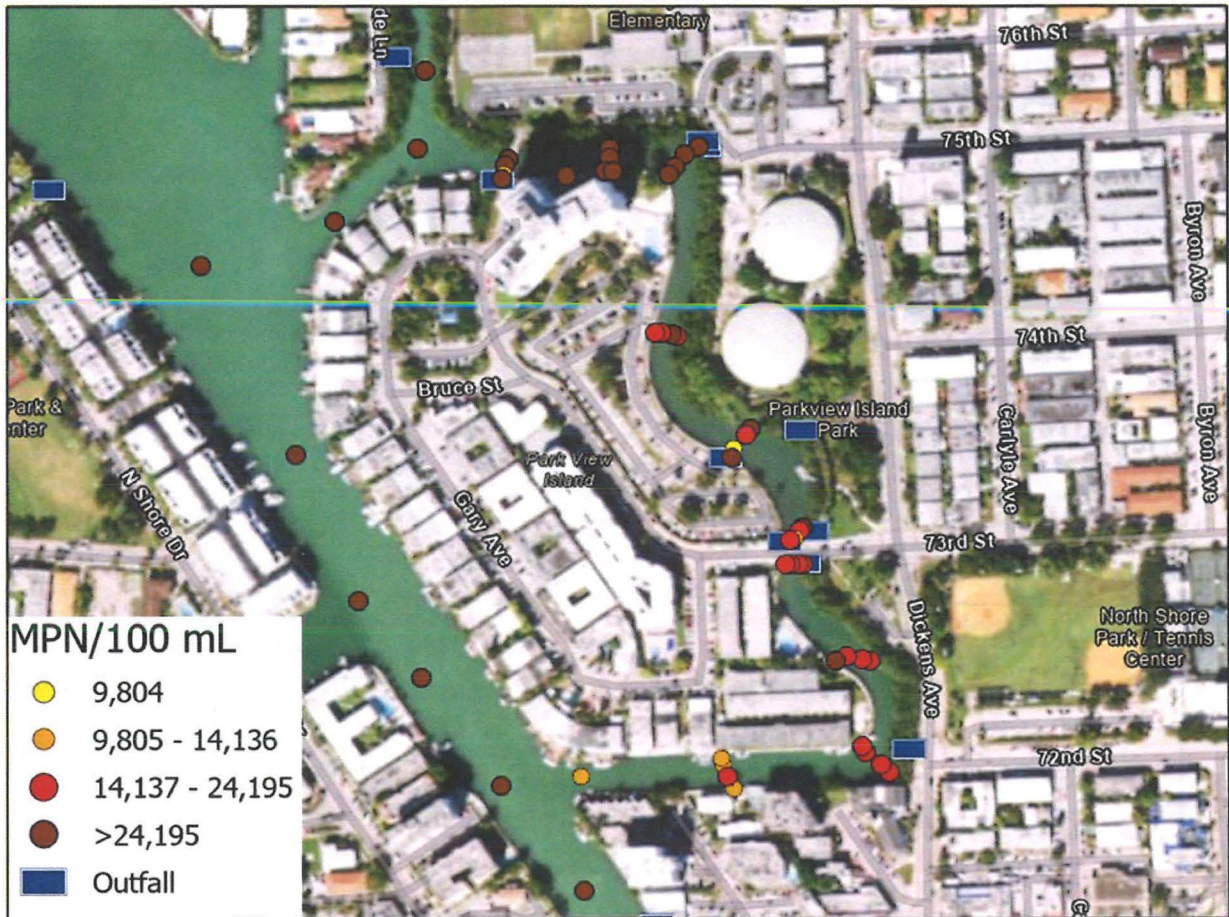
Figure V.3: Map showing measured concentrations of enterococci at the PVC during low tide (September 16, 2022).

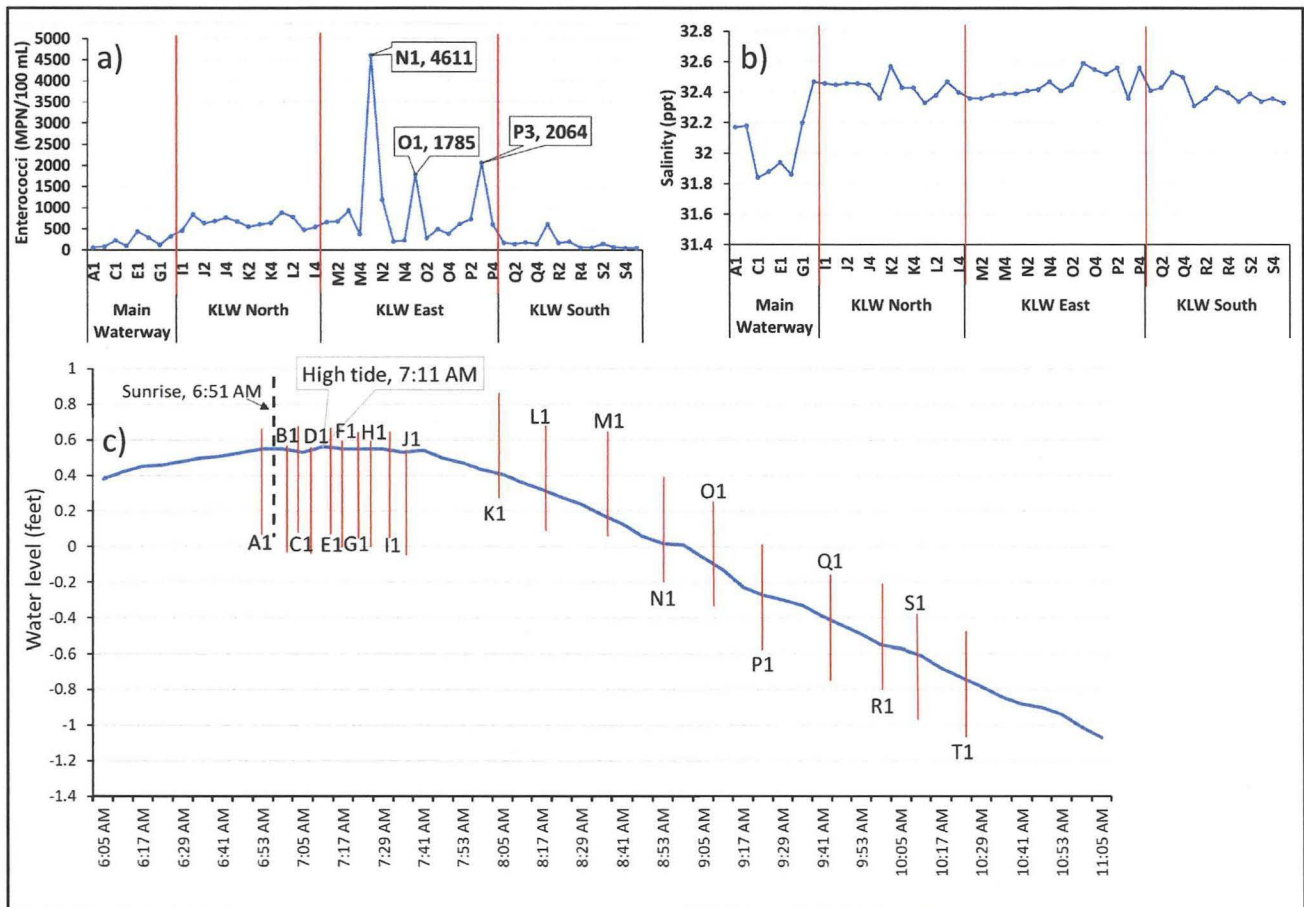
Figure V.4: Panel a) August 19th (high tide) enterococci levels around the perimeter of Parkview Island, Panel b) salinity measurements along PVC. Panel c) water levels (NAVD) during sampling activities.

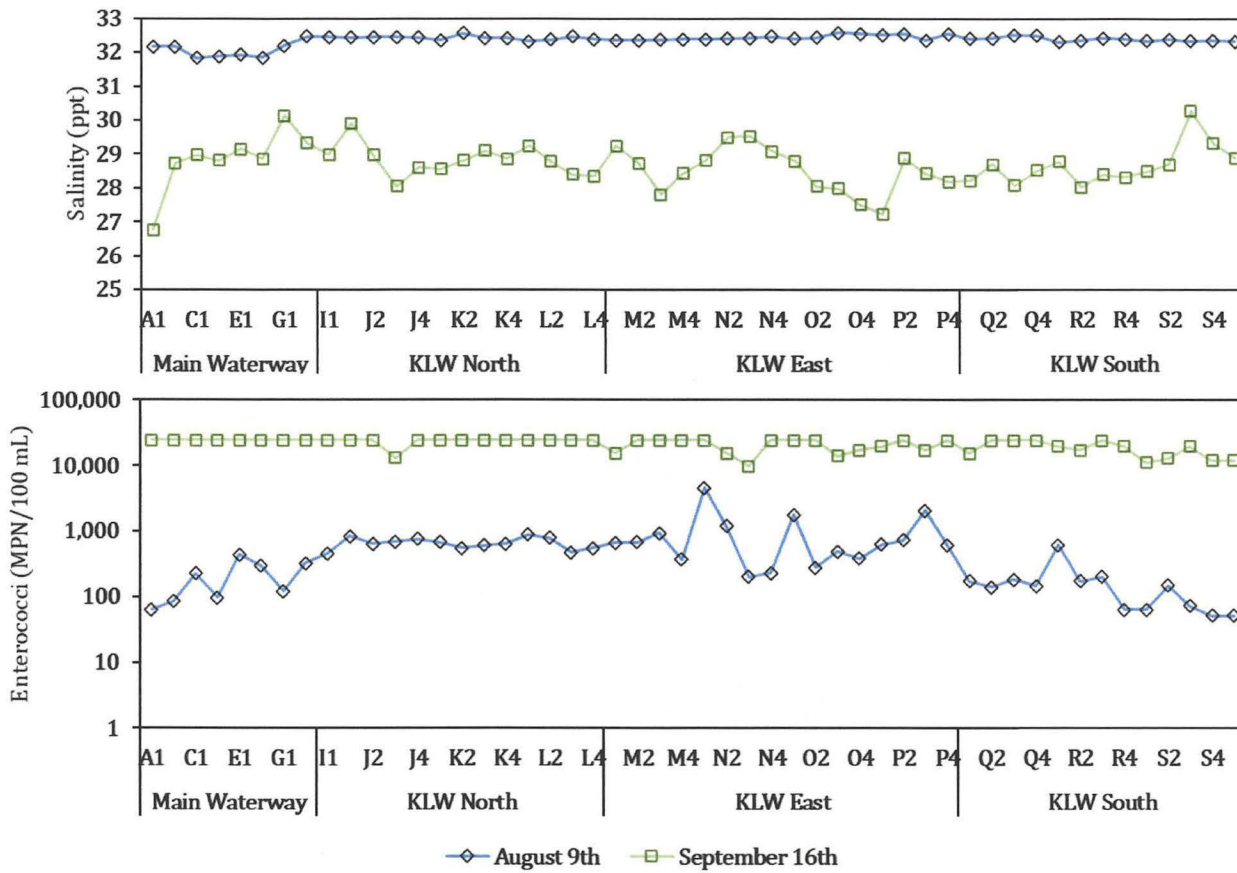
Figure V.5: Results from spatially intense sampling around the perimeter of Parkview Island, comparing the results from the August 19th sampling event (high tide) and the September 16th sampling event (low tide). Top panel compares salinity and lower panel compares enterococci.

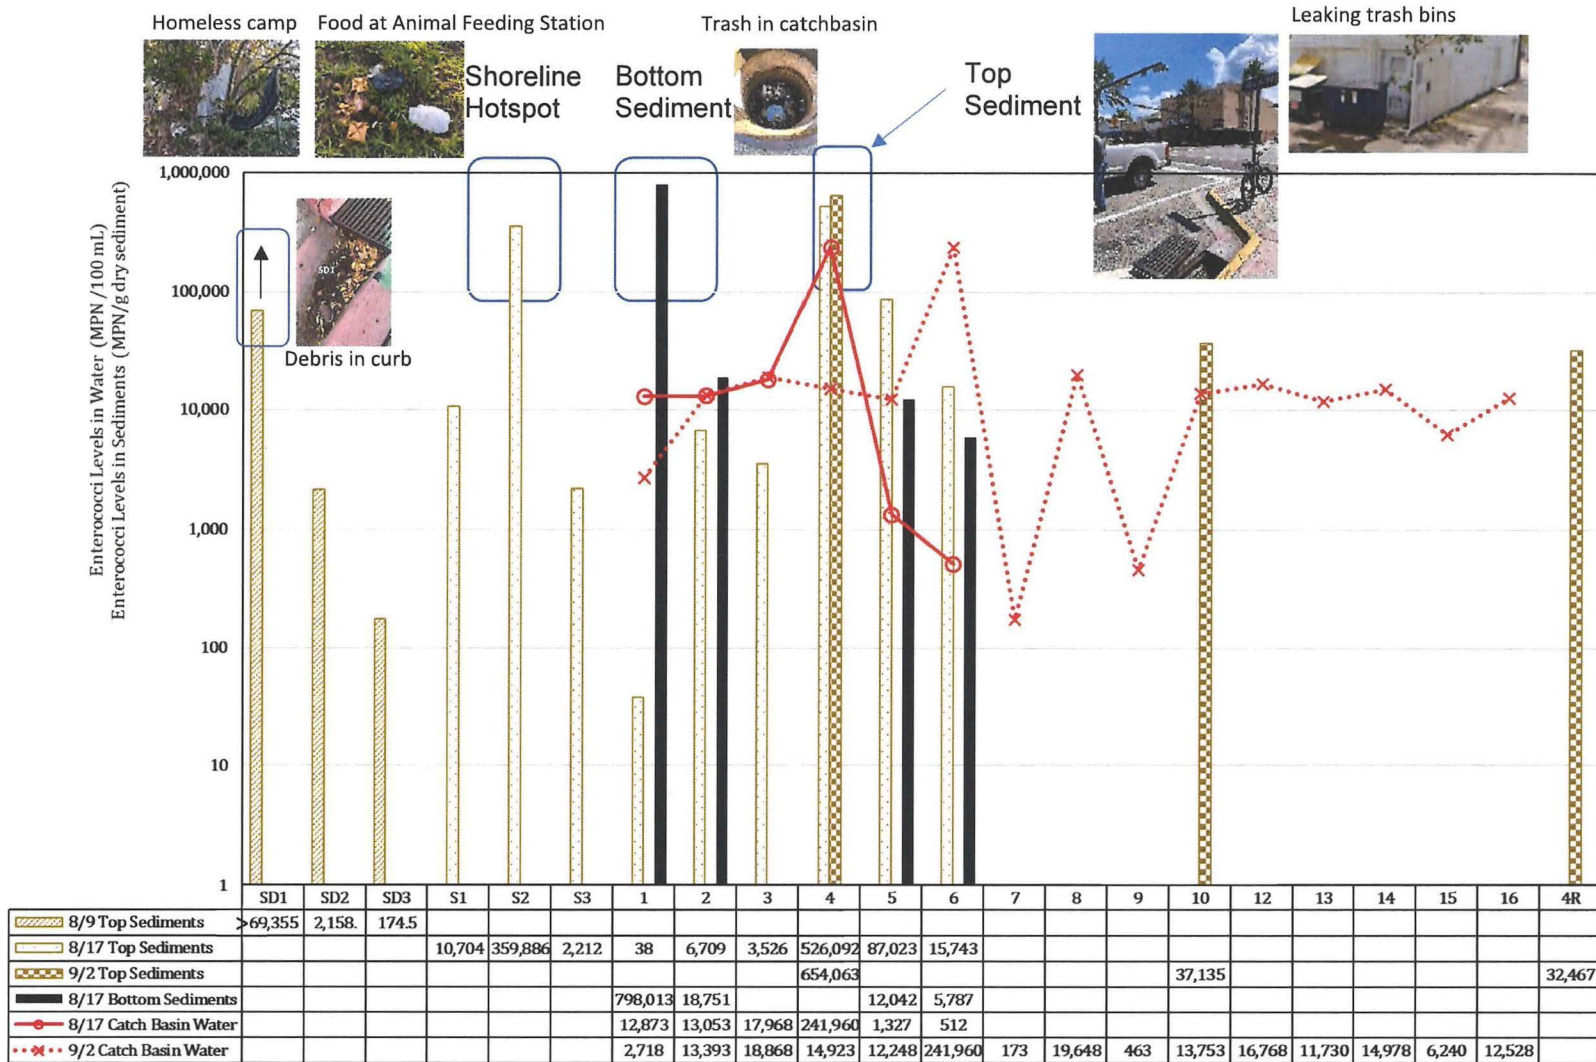
Figure V.9: Results from sediment and water sampling of channel banks and catch basins (August 17 and September 2). Sediment results shown by bar plots and water results shown by lines.

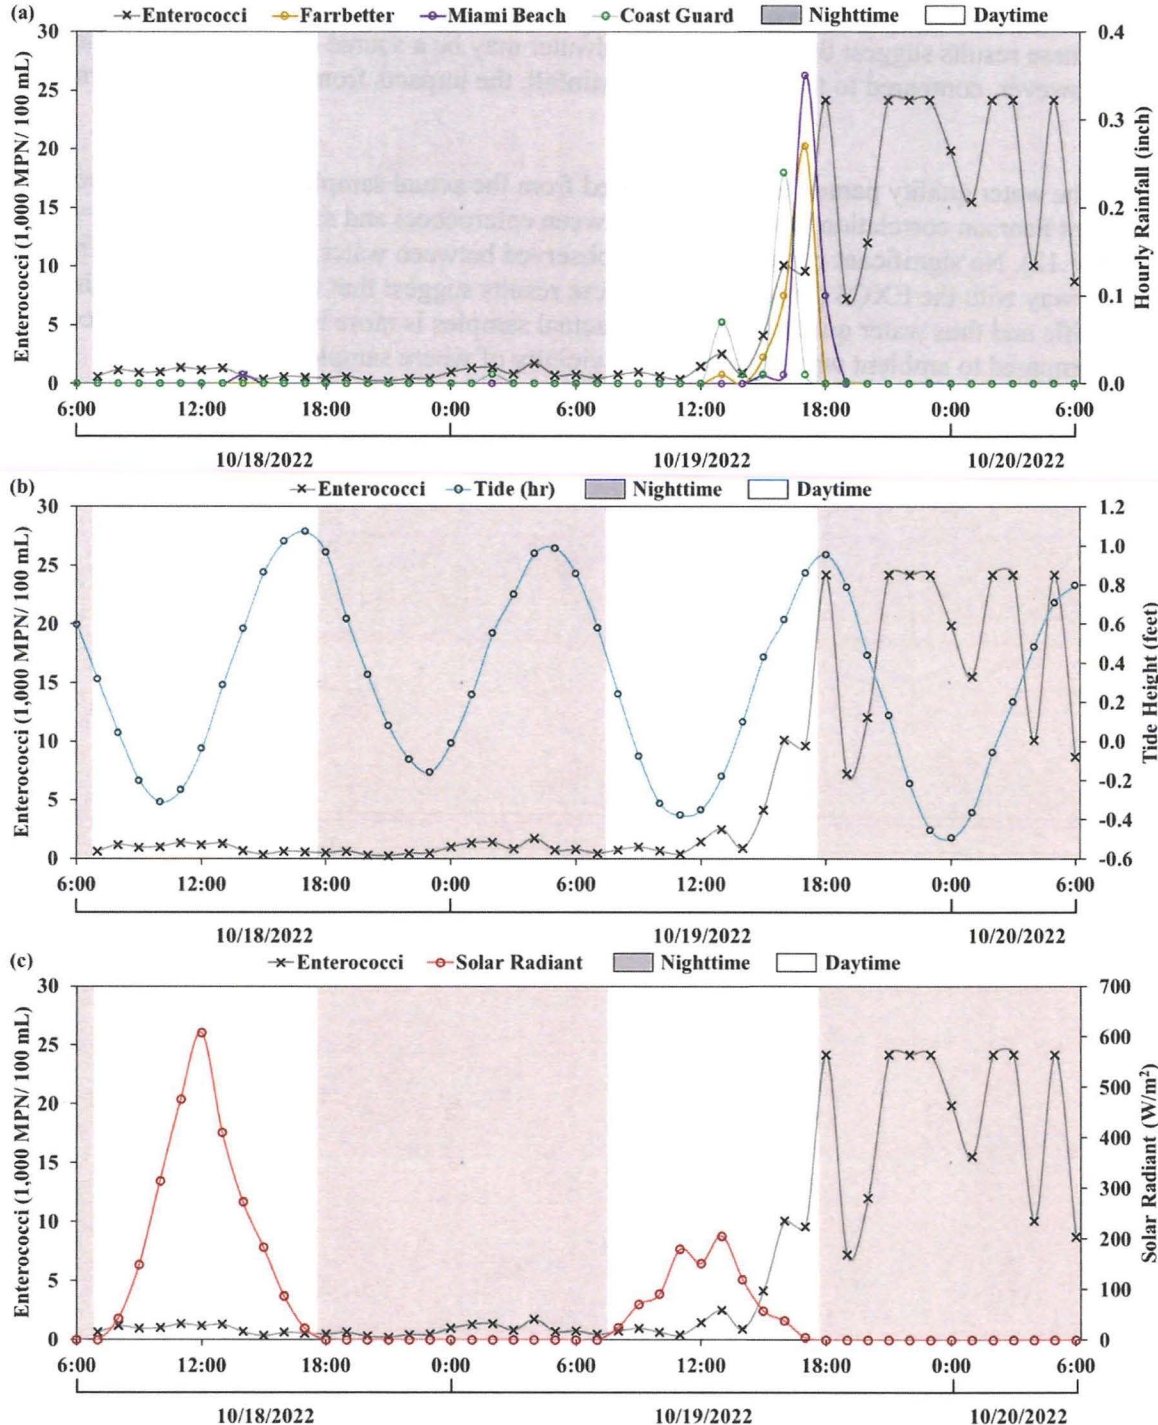
Figure V.10: Enterococci concentration at the K LW during the 48-hour sampling effort along with: Panel (a) hourly rainfall from three closest weather stations; Panel (b) tidal height; and Panel (c) solar radiation. White and grey background indicated daytime and nighttime during the sampling, respectively.

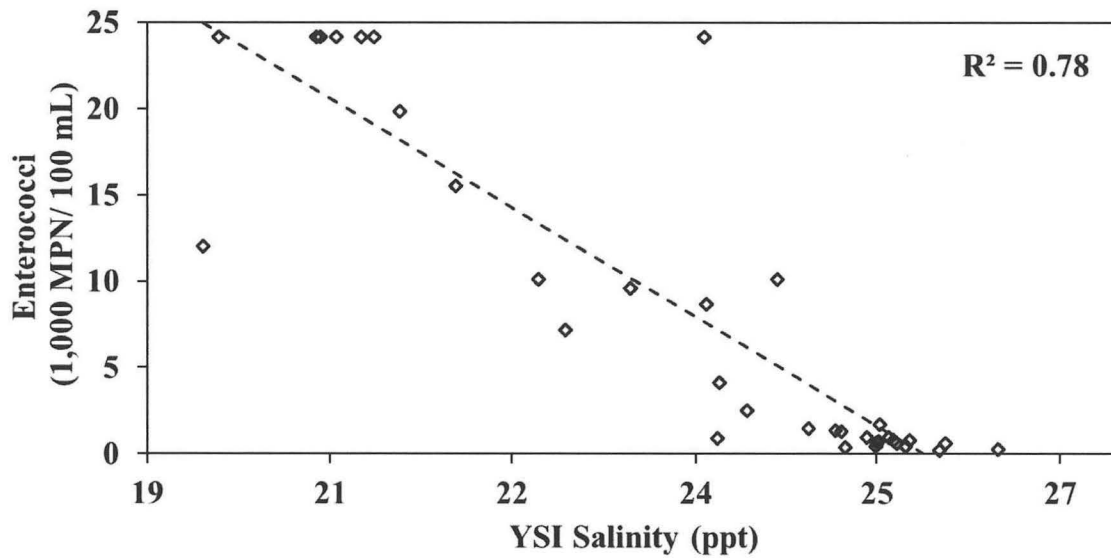
Figure V.12: Linear correlation between the concentration of enterococci and YSI salinity from 19:00 on Oct. 18, 2022, to 6:00 on Oct. 20, 2022.

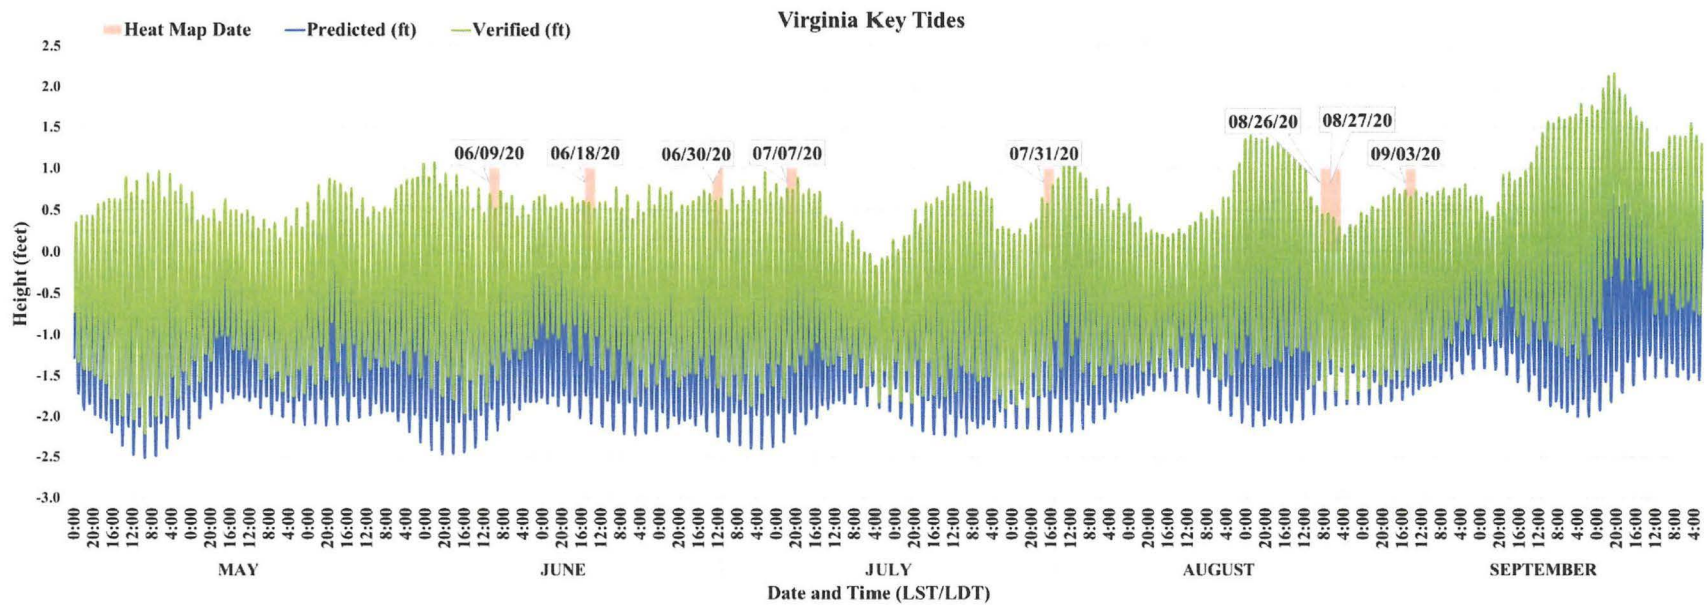
Figure B.4: Virginia Key predicted and verified tides, dates from Heat Maps with FIB peaks
