SUBJECT: Emergency Removal of Pine Trees in the Median on Pine Tree Drive

Australian Pine Risk Assessment for Pinetree Drive

January 8, 2014

by
Chuck Lippi
ISA Board Certified Master Arborist #FL0501B
ASCA Registered Consulting Arborist #443
and Danny Lippi
ISA Certified Arborist FL6145A

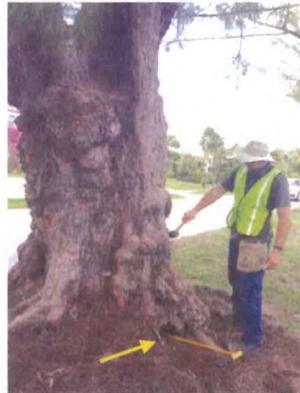
Mallet Test— Sounding the trunk and root flare with a rubber mallet provides one of three possible results: Negative, which means no hollow cavity was found, positive, which means a hollow area was found, and inconclusive, which means a possible cavity but sounding was not conclusive (Figure 5).

Figure 5 A rubber mallet was used to test each tree for hollows or hidden cavities in the trunk. The mallet is very effective for detecting trunk decay but not for detecting basal decay. A probe is used to test for basal cavities near the base of each tree (see arrow).

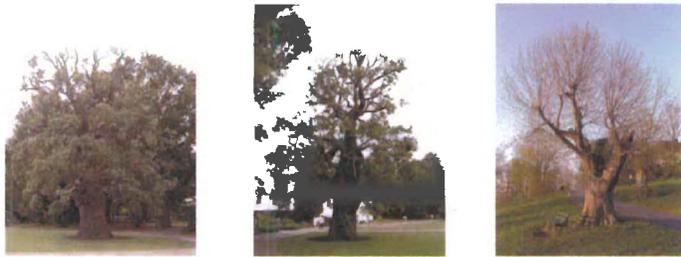
Figure 15 Here are three examples of crown reduction management of declining veteran trees in Europe. Even with heavily decayed trunks the smaller managed crowns exert less force on the trunks allowing the trees to remain in a reduced form long beyond their prime. Photos provided by Philip van Wassenauer, ISA Certified Arborist and tree preservation specialist from Mississauga, Ontario.

Long Term Crown Reduction Management Plan - This type of treatment of crown reduction was described at a veteran tree conference given in Asheville, NC in 2008 by tree preservation specialists Philip van Wassenauer and Neville Fay. Crown reduction can be used as a specific risk reduction technique when used on aging trees. The conference concentrated on European methods of preserving and maintaining aging and declining veteran trees mainly through gradual crown reduction. Aging trees are managed instead of being allowed to naturally senesce, break apart and fall over. Longer branches are shortened and height is reduced gradually over a period of years similar to the crown reduction pruning treatments described by Dr. Coder. Left alone an aging tree would begin shedding its longer, taller branches through the activity of decay and the forces of wind storms. This haphazard branch and sometimes trunk shedding is dangerous and uncontrolled. But a crown reduction management program could allow many the declining Australian pine trees to continue to live on Pinetree Drive for many more years with reduced risk to those who use the street.
